University of South Carolina Campus Wall Historic Structure Survey

University of South Carolina Campus Wall Historic
Structure Survey
Columbia, South Carolina

Spring 2011

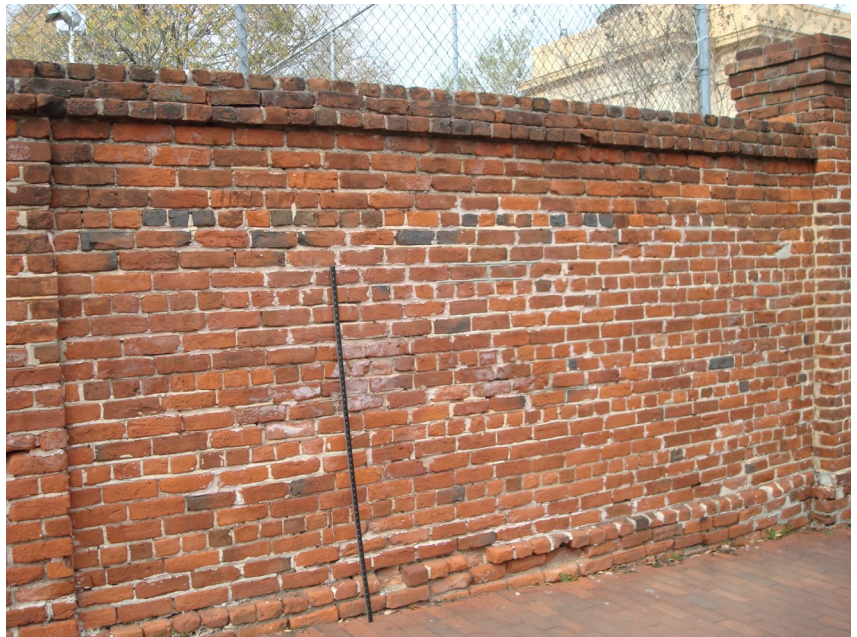
Figure 6: GO47, full.

GO47, located at the corner of Greene and Bull streets, is a notable example of this type. The section is 15 feet 8 inches long, and, as it is located at a slant in the sidewalk, its height ranges from 7 feet 4 inches to 8 feet two inches. The corner is denoted by a 9 feet 11 inches tall pillar that is 2 feet 2.5 inches square. This section is composed of handmade brick laid in 1:3 bond. The slope in the sidewalk uncovers several inches of the original foundation of the wall.

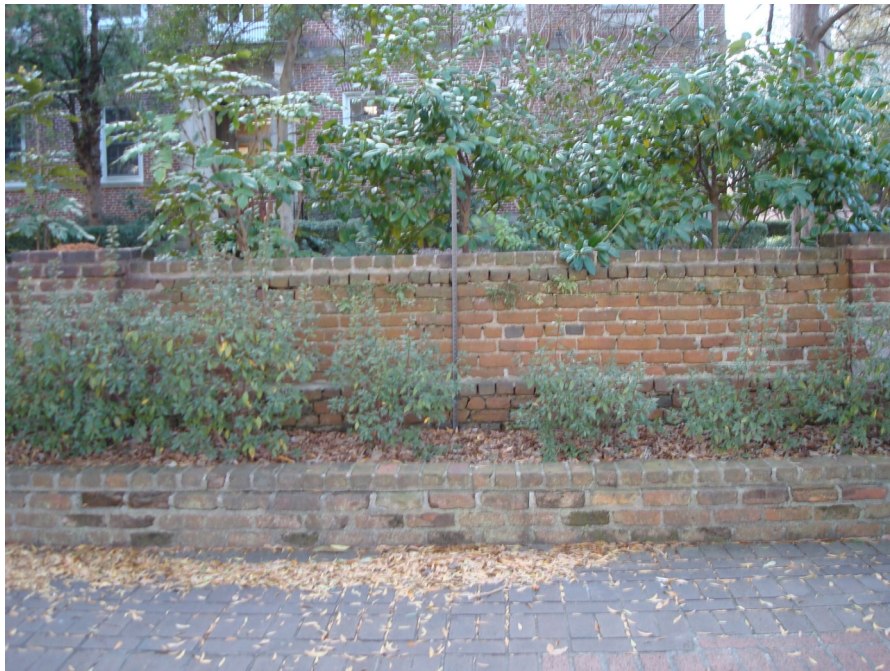
Figure 7: BO15, full.

BO15, located on the southeast end of Bull Street, is representative of this type. This section is 13 feet 8 inches long and is 3 feet 5 inches high, and is composed of dark red and brown handmade brick laid in 1:3 bond. Although the bonding pattern is consistent with the historic wall, the difference in brick makes it likely that most of this section was rebuilt from historic brick salvaged from another structure.

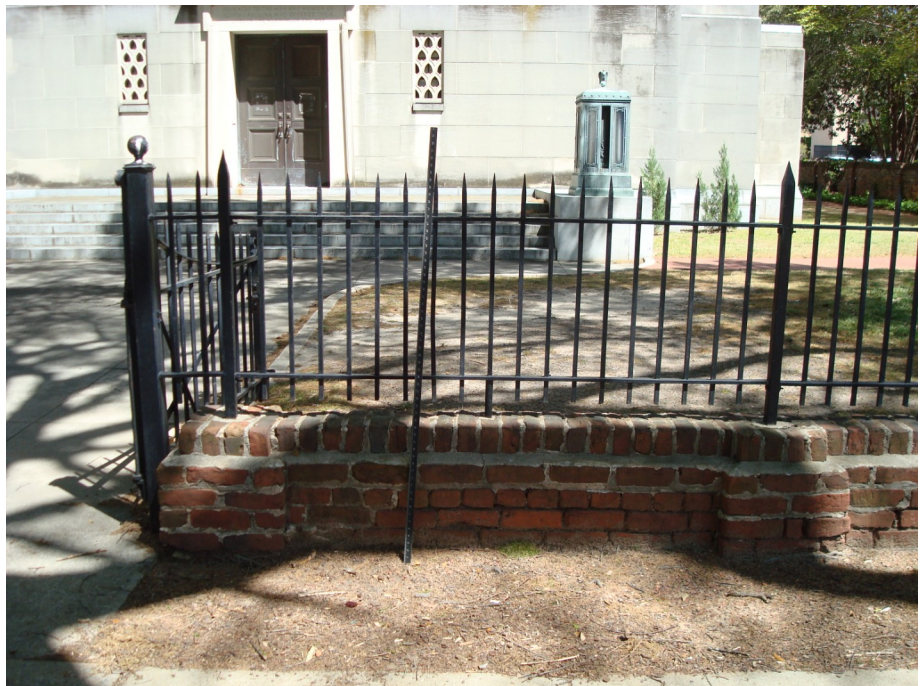
Figure 8: SO2, detail.

The entire section labeled as SO2 exemplifies this type. Where the wall fits this type, it was recorded as one large segment. Distances between the remnants of pillars within the sections were noted. The brick wall is 1 foot 6 inches high, and is 4 foot 2 inches high including the wrought iron fence. It is composed of dark red brick and is laid in a pattern so the row of headers is consistent with the base of more intact portions of the wall. Based on the placement of pillars, bonding pattern, and brick color, this section may be largely built from the original base of the wall.

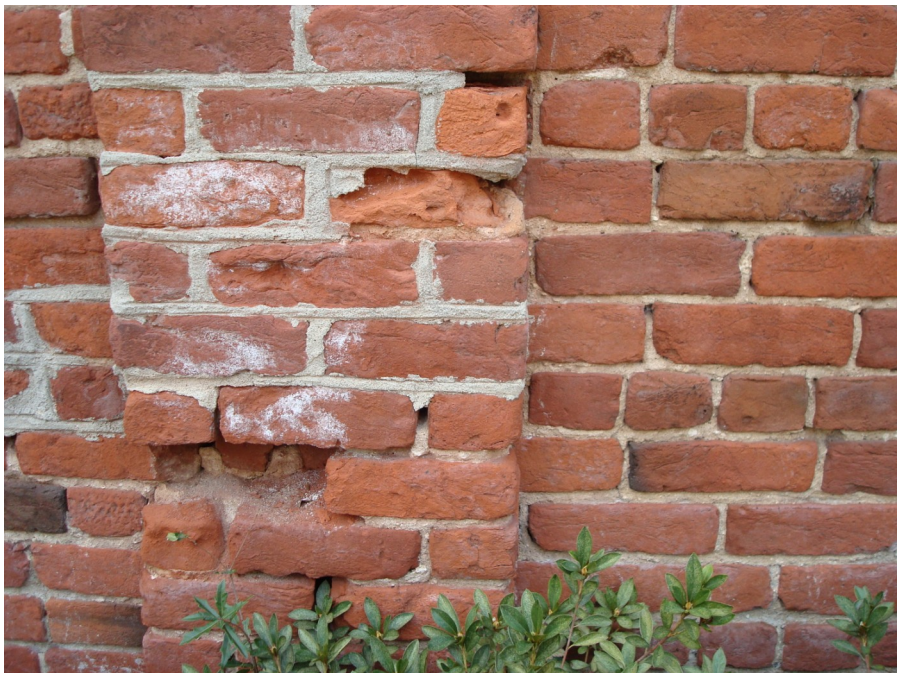
Figure 9: BO3, detail.

Brick Damage is a problem in nearly every section of the wall. Underfired "salmon" bricks in the wall face are exposed to moisture, and have been slowly melting away. Due to spalling from absorbed moisture, some bricks are missing their faces entirely. This leaves those bricks vulnerable to further deterioration. At most entrances, there is clear evidence of vehicle damage on corners of the wall. Bricks in the lowest row of corbelling tend to be chipped, and sometimes broken in half. Perhaps most distressingly, there are a number of bricks that are missing from the wall. This is most notable where bricks have come loose in the corbelling, but there are also cases where bricks are missing from the center of the wall. Anecdotal evidence suggests that bricks from the wall are popular souvenirs for University of South Carolina students.

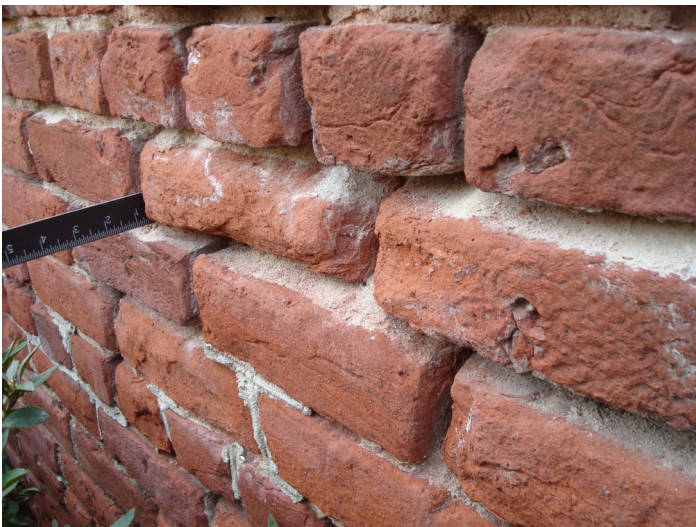
Figure 10: BO2, detail.

Concerns about **mortar** can be split into three specific concerns. These include the need for repointing, improper repointing in modern cements, and careless repointing. Whether by choosing to do nothing or doing work without thought for the impact on historic materials, the result of further deterioration of the wall is the same.

Large parts of the wall have been repointed in modern cements. Many modern cements are inappropriate for use in historic masonry structures because they are harder and stronger than the bricks themselves. The bricks often expand and contract based on weather conditions, but modern cements do not. This causes damage to the bricks, and further destabilizes the wall.

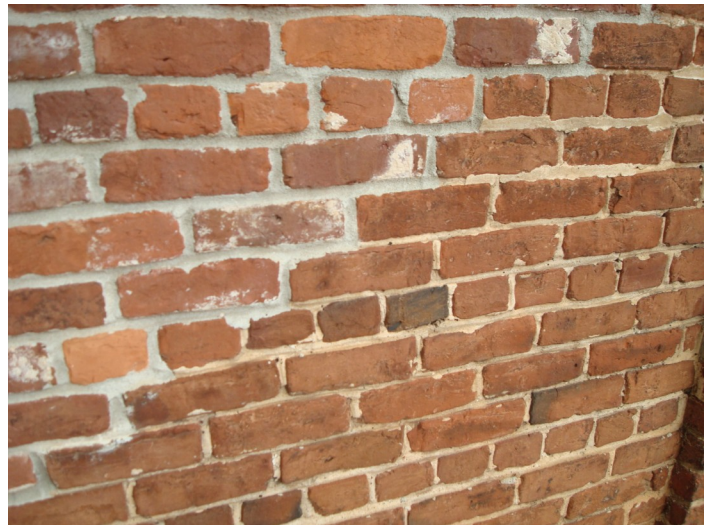
Figure 11: SO36, detail.

In some areas of the wall, there is dire need for repointing. Over time, older mortars have weathered to the point that they barely exist—or in some cases are simply no longer there. These sections of the wall leave bricks open to weathering, damage, and theft.

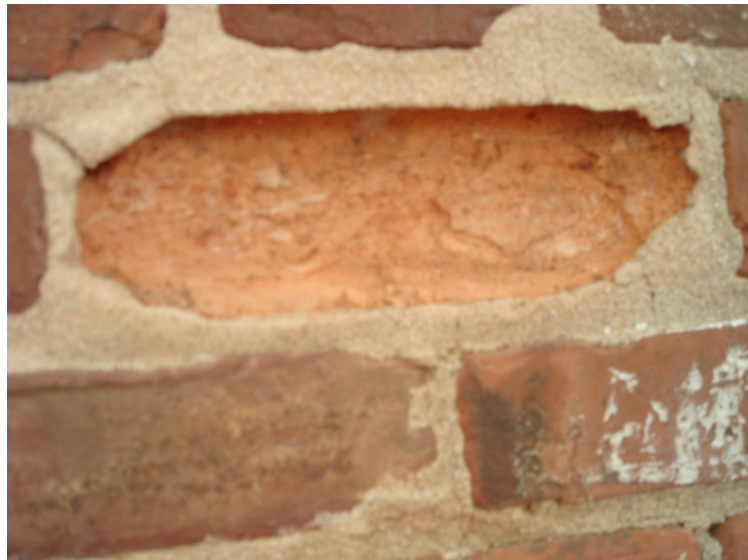
Figure 13: GO16, detail.

Careless repointing was noted as a consistent problem during the survey. Repointing, particularly in areas of the wall that are not easily accessible, can be a difficult task. Poor repointing is not simply an aesthetic concern, but also a practical one. Globbs of mortar can serve as shelves or pools that attract more water to the wall and contribute to brick damage over time.

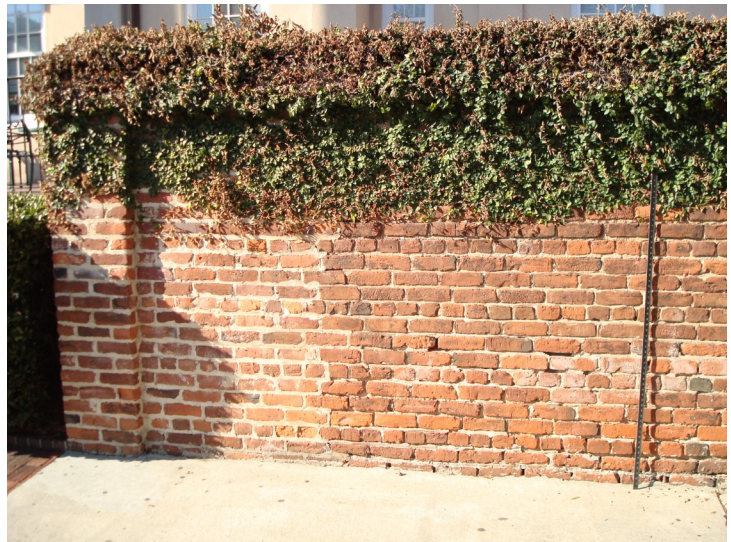
Figure 14: GO21, full.

The overabundance of **plant life** is of particular concern. This ranges from small plants and trees growing from the corbelling to large scale growth of vines, such as can be found around Preston College. Although the latter can be aesthetically appealing, the roots from the plants grow into the bricks and mortar and make a significant contribution to the destabilization of the wall.

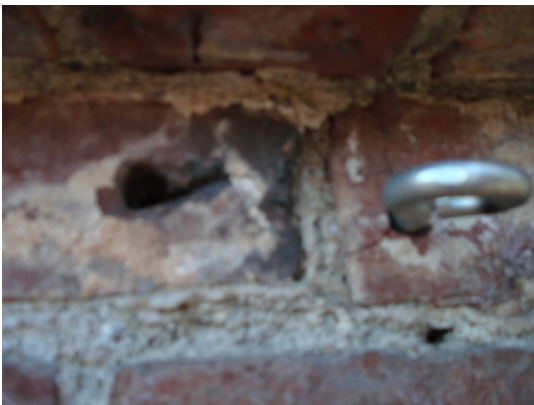
Figure 15: GO33, detail.

Nails and other intrusions have been nailed into the wall, particularly on Sumter and Greene streets. There are also a number of holes in the mortar where nails have since been removed. The majority of the nails found during the course of the survey seemed quite old—we enjoyed discovering that former students used bottle caps as washers. The modern bolts placed in the wall seem to have helped solve the problem of student organizations slowly destroying the wall with each new posted sign. However, enough recent nails were found to cause concern.

2. Address the issue of hanging banners and signs on the wall.
Although most students are unaware of the wall's existence, the Greene Street façade of the wall is used extensively as a hanging place for banners and signs that student and other school groups use to advertise various events. Unfortunately, this modern use has severely damaged the wall, as nails, screws, and other materials have been driven into the historic handmade bricks that comprise the wall. This use exponentially degrades the structural integrity of the wall. The best recommendation would be to ban team and other groups from using the wall in this manner; however, if that were not suitable, this survey team recommends that the hanging of banners be limited to only using existing screws, nails, and hooks that already have been inserted into the wall. At the very least, this team recommends that no new holes be driven into the wall.

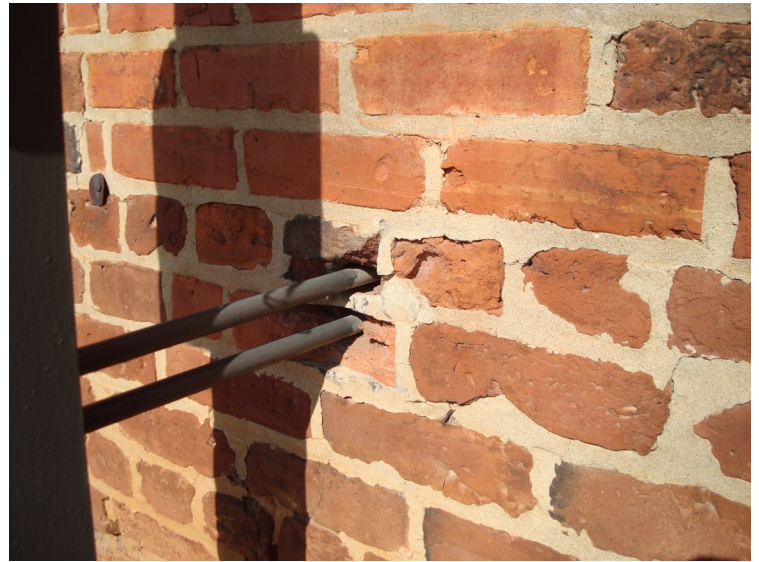
Figure 17: GO1, detail.

Structural instability has been caused by a number of other problems as well. When the two emergency phone kiosks were built along Greene Street, they were bolted through the bottom of the wall. The structural damage that this has caused is evident, and it appeared that sections of the wall had to be rebuilt as a result.

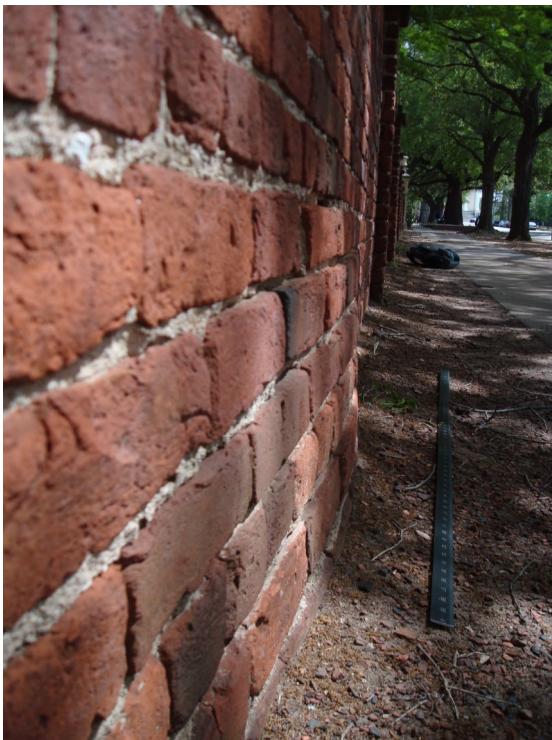
Figure 18: SO9, detail.

A tree growing near the wall in the garden of the South Caroliniana library has caused noticeable bowing in the exterior of the wall. In a few cases, sections of the wall were found where the top half is set back from the base by a half inch or more with no clear reason. These particular issues will need to be addressed in the near future.
